115 North Duke Street

Fatal Natural Gas Explosion
Origin and Cause Investigation Report
Incident No. 19-1909574
April 10, 2019

Brian Graves
Assistant Fire Marshal
City of Durham Fire Department
August 2, 2019

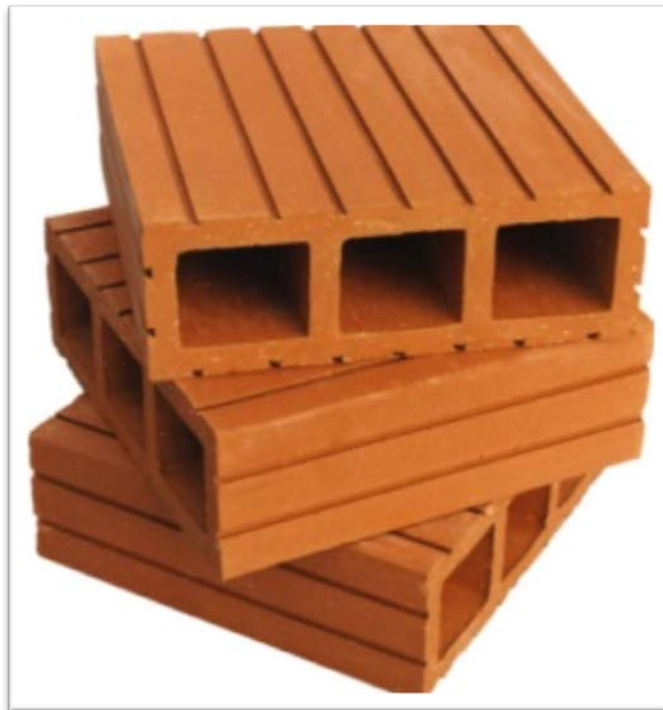
The primary affected structure on 115 North Duke Street was a 2-story, adjoined building with primarily brick walls, hollow core clay tile floors (Figure 8), mixed wood-framed and steel-framed, drywall sheathed interior walls. The roof assembly consisted of open-web steel bar joists supported on steel beams and brick columns. The second floor above Kaffeinate was poured concrete on corrugated steel, supported by open-web steel bar joists supported on steel beams and columns, built sometime in 1920 (Durham County tax records). The original use of this building was an automotive dealership (Figure 9). The combined square footage of both adjoined buildings is 20,872 sq. ft. (Durham County tax records). The two buildings on this curtilage had been blended together through doors and cased openings. Kaffeinate occupied approximately 1,500 sq. ft. of the structure addressed as 115 North Duke Street. Prescient (115A North Duke Street) occupied the rear and upstairs portion directly above Kaffeinate and portions of the connected building. The first floor of the adjacent building 115 North Duke Street, Suite 1-B in Durham, NC (on the corner of Morgan and Duke Streets) was occupied by Main Street Clinical Associates (MSCA). The main entrance to this business was off of the courtyard behind the building.

Figure 8 depicts the type of clay tile sub-floor in 115 North Duke Street

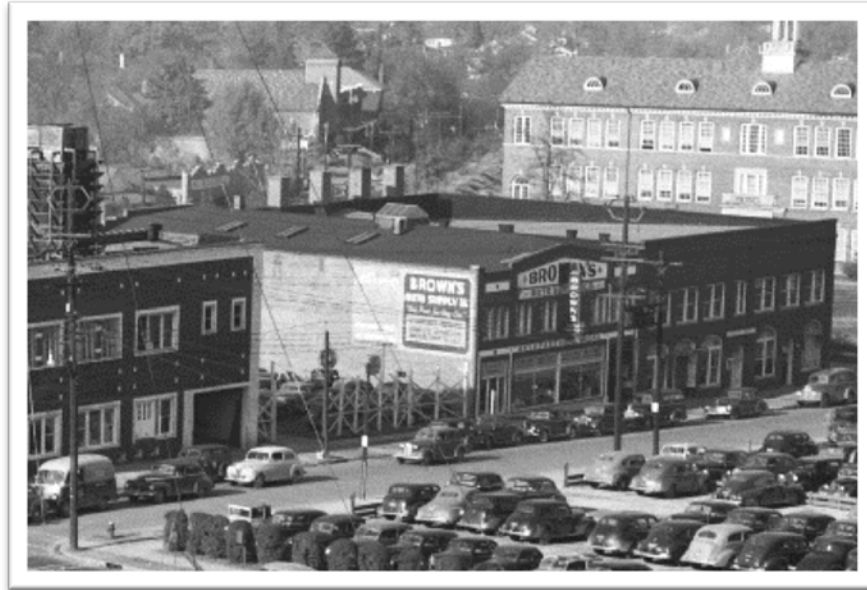
Figure 9 depicts the original use of 115 North Duke Street as a Studibaker dealership

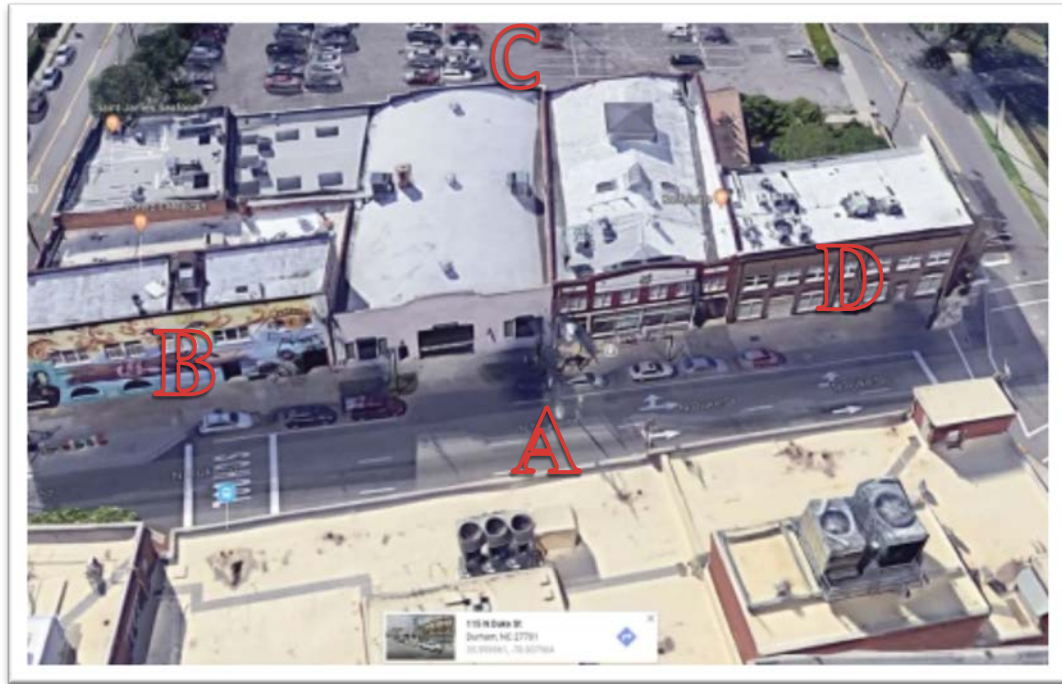
The front of the building (Kaffeinate) faced North Duke Street and was denoted the “Alpha (A)-side.” All reference to orientation of direction is clockwise from that cardinal point (Figure 10). It should be noted that this building had additional tenant space that utilized the rear and second floor of the primary structure and in the adjoined building through cased openings. Prescient and Main Street Clinical Associates was addressed as 115 (A and 1-B, respectively) North Duke Street, but the main entrance of both of their spaces was considered to be on the “Charlie (C) Side” of the structure in the rear court yard. Occupied exterior dimensions did not form a complete rectangle, but closely resembled an “L” shape. This area, if present, would not have any significant effect on the findings of this investigation and was not explored.

- A-side (east), approximately 130’
- B-side (South), approximately 115’
- C-side (West Prescient), approximately 65’
- D-side (North Prescient), approximately 62’
- C-side (West MSCA), approximately 75’
- D-side (North MSCA), approximately 50’

Figure 10 denotes 115 North Duke Street orientation

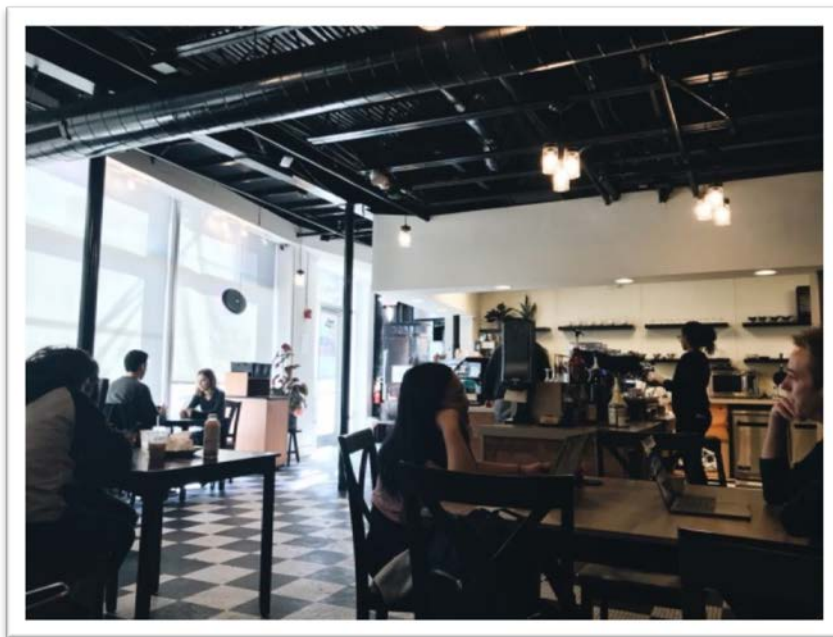
The main entrance to Kaffeinate was a single glass door located at the Alpha Side near the Alpha, Bravo (A-B) corner of the building. This shop occupied an estimated 1,500 square feet with a glass store front. The interior configuration consisted of a service area of approximately 400 square feet located on the Bravo side (B-side) interior wall. This area had a Turbo air open display merchandiser refrigerator, waffle irons, microwave, dishwashers, point of sale cash register, and coffee brewing appliance. The rear had a small prep/storage area and bathroom adjacent to it. The seating area had numerous tables and chairs of various sizes and configurations located towards the midline and Delta side (D-Side) of the shop.

Figure 12 denotes interior configuration of Kaffeinate

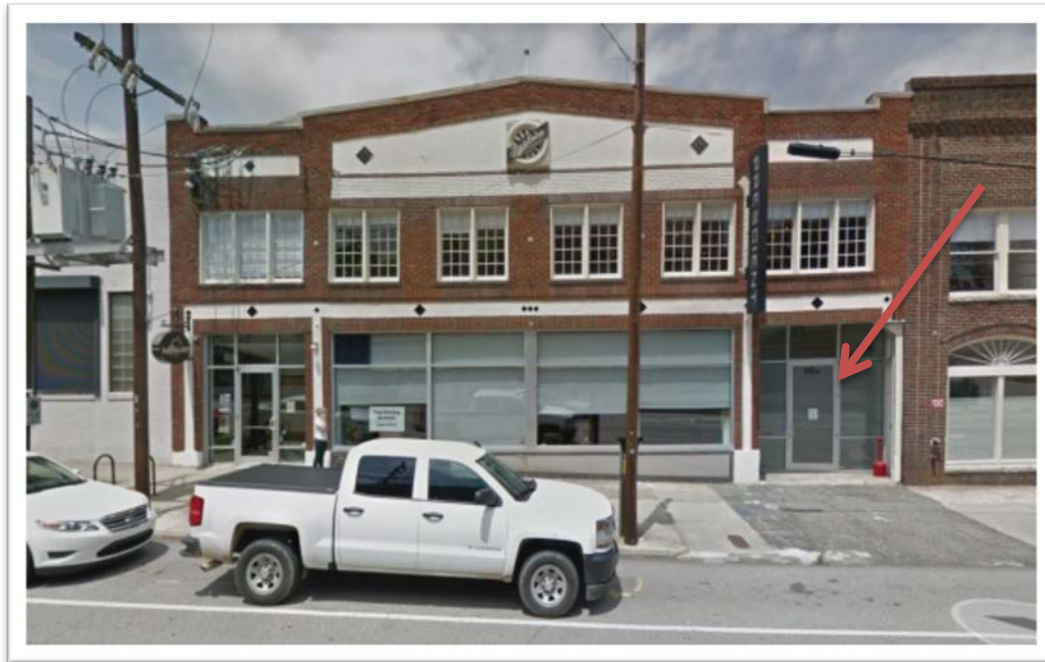
There was a staircase and entry door located along the east wall at the front of the structure's "A" Side. These stairs entered the area of 115A North Duke Street, that was occupied by Prescient. These stairs were functional prior to the explosion and were noted to be used by C.K. Key of Prescient Company on the morning of the explosion. Prescient occupied a combined space

Figure 13 denotes stairwell entrance to Prescient

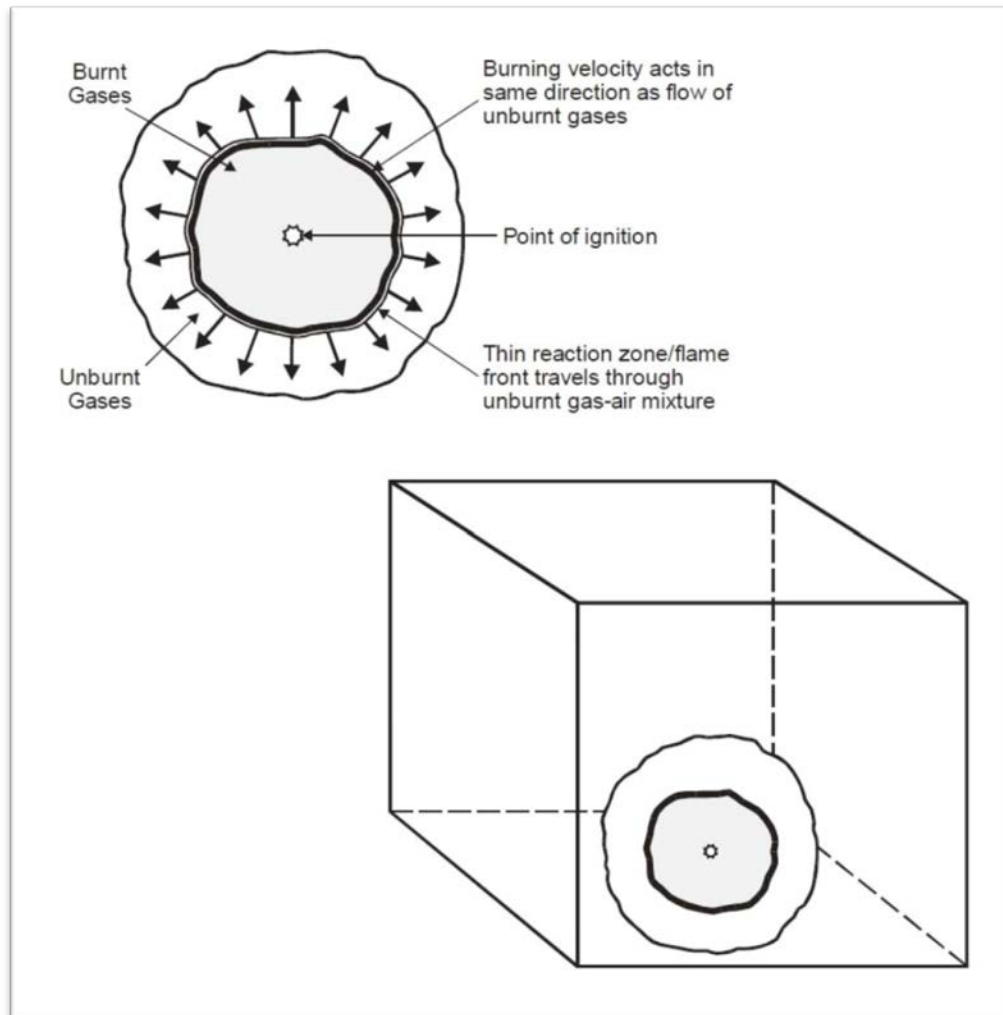
1. The sequential pattern analysis of the explosion effects and fire patterns, including char analysis, heat and flame effects analysis, and the movement and intensity patterns, indicate the detonation originated in Kaffeinate on the first floor of 115 North Duke Street. In explosion flame propagation, the fuel (natural gas in this example) encounters an ignition source, burning velocity acts in the same direction of flow as unburnt gases. A thin reaction zone/flame front travels through the unburnt gas-air mixture (Figure17). A large fire ball was associated with this explosion. This fireball is attributed to a buoyancy driven force resulting from a combusting vapor cloud. When a fire develops in a compartment, the products of combustion (i.e. heat, soot) begin to influence the materials within the compartment. Consequently, the lining materials for the walls, ceiling, and floor, as well as the various contents within the compartment, are damaged by their exposure to the products of combustion. The variety of damage to these objects is collectively known as fire effects.

Figure 17 depicts propagation of an explosion flame

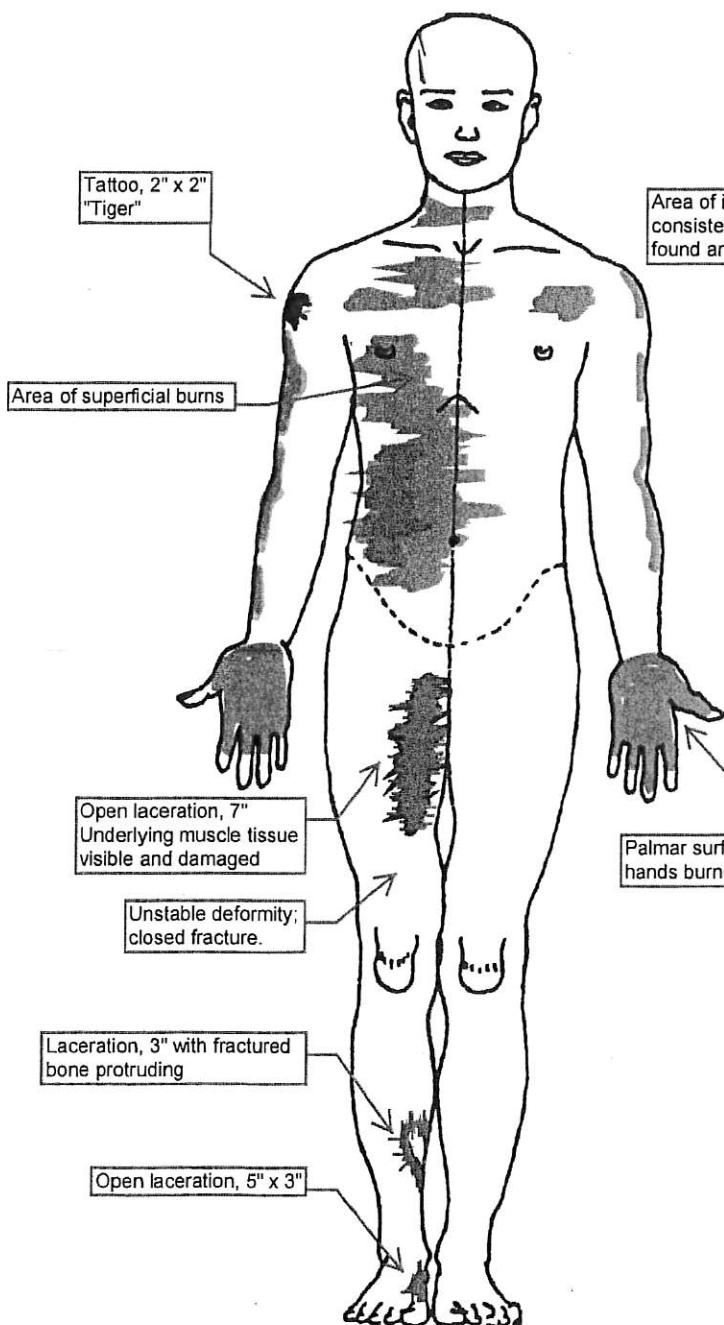
Laceration, 1.5"

Tattoo, 2" x 2"
"Tiger"

Area of superficial burns

Open laceration, 7"
Underlying muscle tissue
visible and damaged

Unstable deformity;
closed fracture.

Laceration, 3" with fractured
bone protruding

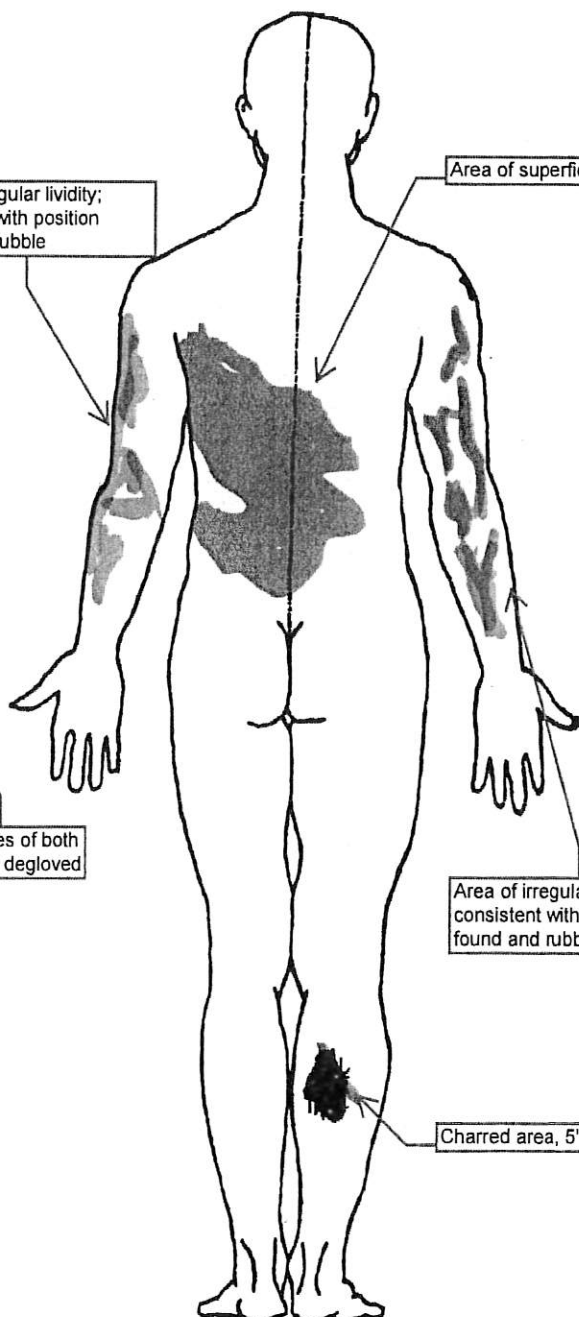
Area of irregular lividity;
consistent with position
found and rubble

Palmar surfaces of both
hands burned, degloved

Area of superficial burns
